ISOLA SERAFINI (PIACENZA - ITALY)

Consolidation and stabilization of caissons 3AS, 4AS, 5AS and 4SD of the power plant at Isola Serafini – Monticelli d’Ongina (PC).

March 2000 - September 2001

ENEL

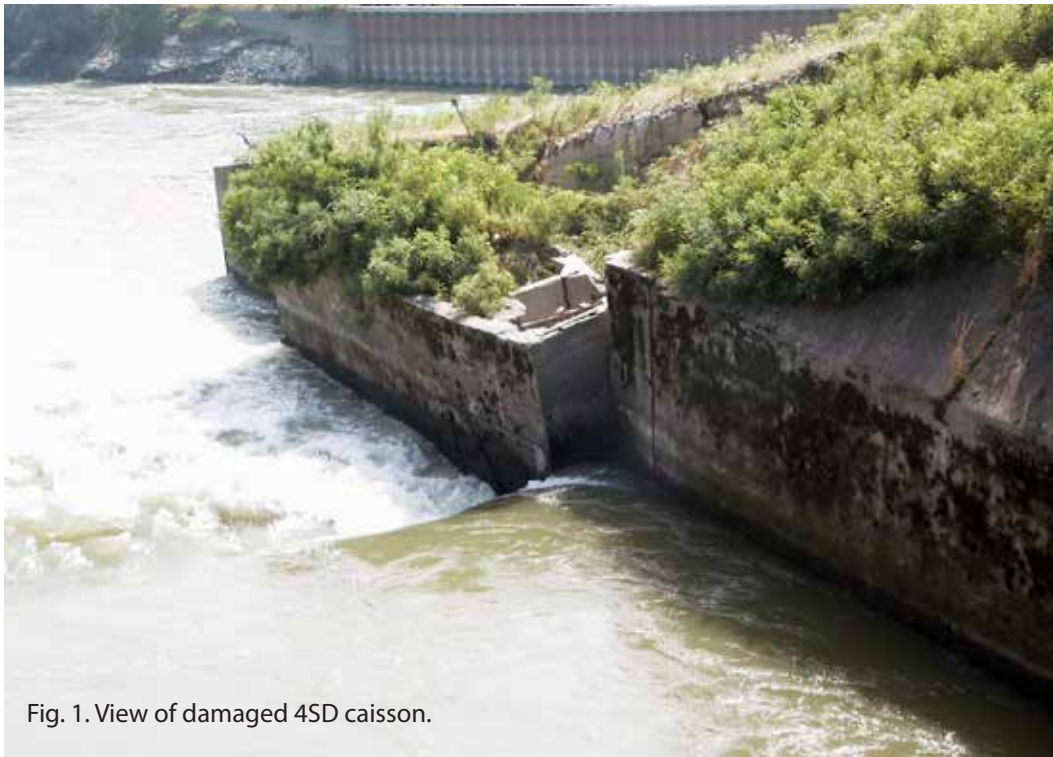
Fig. 1. View of damaged 4SD caisson.

The Isola Serafini power plant, built on a broad curve in the Po river in the municipality of Monticelli d’Ongina (PC), consists of a dam, an inlet and a discharge channel. Over the years, the bed of the discharge channel has sunk, during to the scouring action of the river’s flood tides, when large quantities of water flooded the channel.

This caused movement and partial rotation of one of the self-sinking caissons (4SD), built on the right bank (Fig. 1). The risk of further movement made it necessary to

perform works of consolidation and recovery of the caisson structure (Fig. 2).

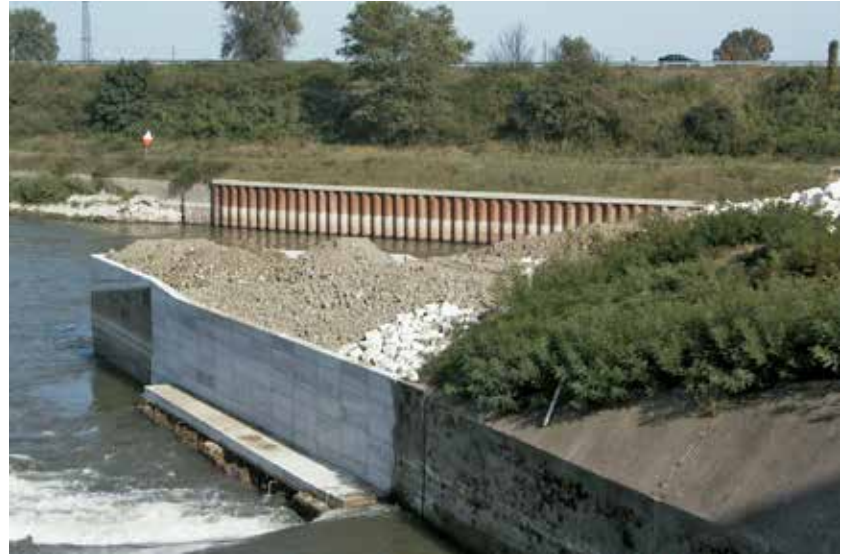
Fig. 2. View of caisson 4SD after the works.

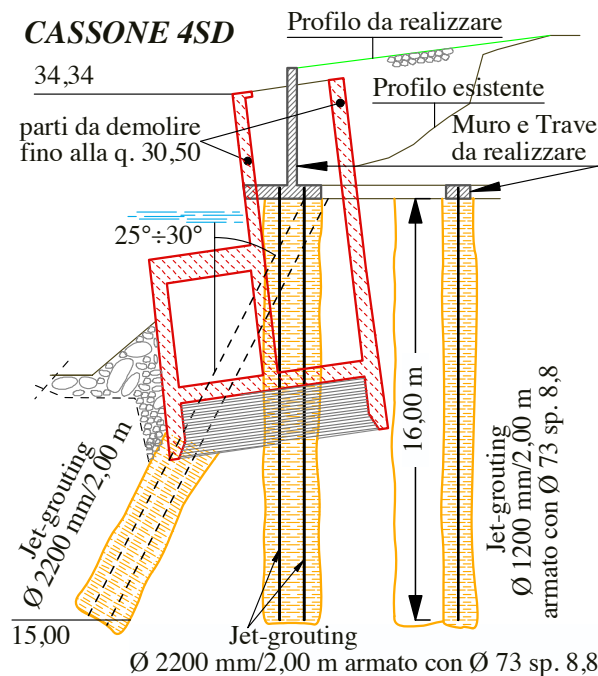
Fig. 3. Sketch of the works

The works required 3 different treatments:

1. Consolidation and waterproofing of the foundation soil under the caisson.

The work was done with two row of quincunx columns spaced 1 m apart, with the following characteristics:

- a Spacing: 2 m;
- a Diameter: 2,50 m;
- a Length: 6-8 m;
- a Angle: variable between 25° and 30°.

The works were performed in four stages:

- demolition of the upper part of the caisson;
- consolidation of the lower structure;
- construction of a wall in reinforced concrete;
- reburying of the caisson.

The works of consolidation were carried out using **PACCHIOSI PRS3** technology.

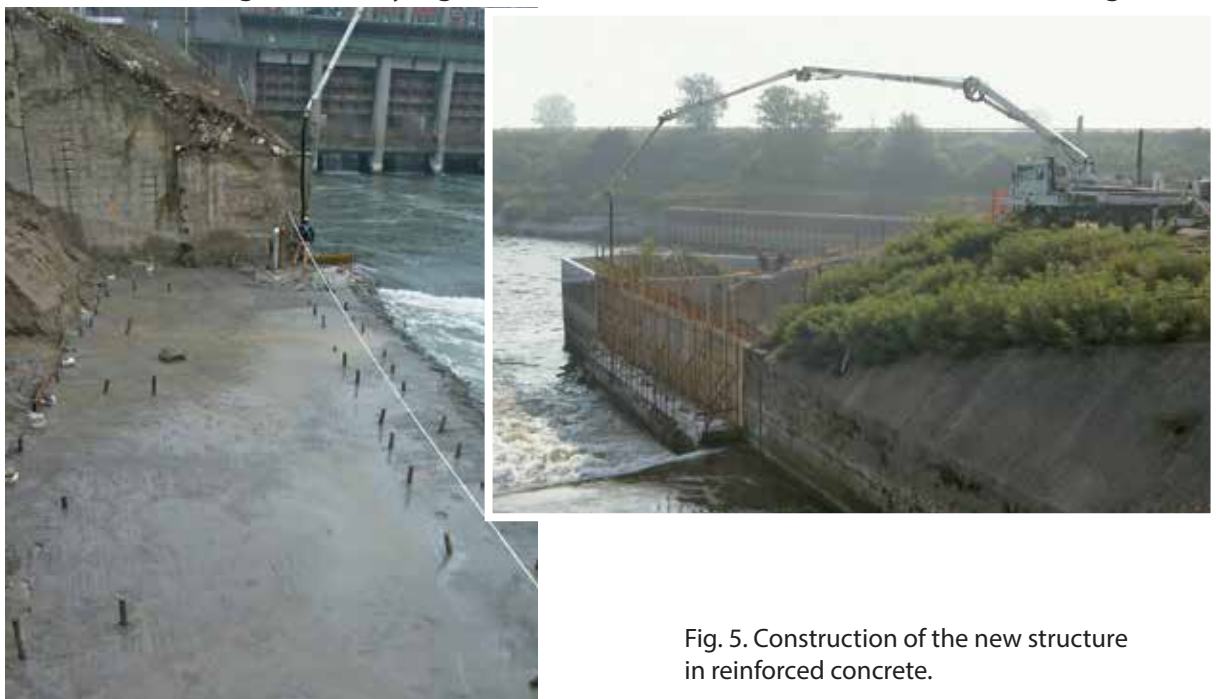
Fig. 5. Construction of the new structure in reinforced concrete.

The works of consolidation were followed by construction of the new structure in reinforced concrete (Fig. 5), reburying the caisson and construction of a stone facing.

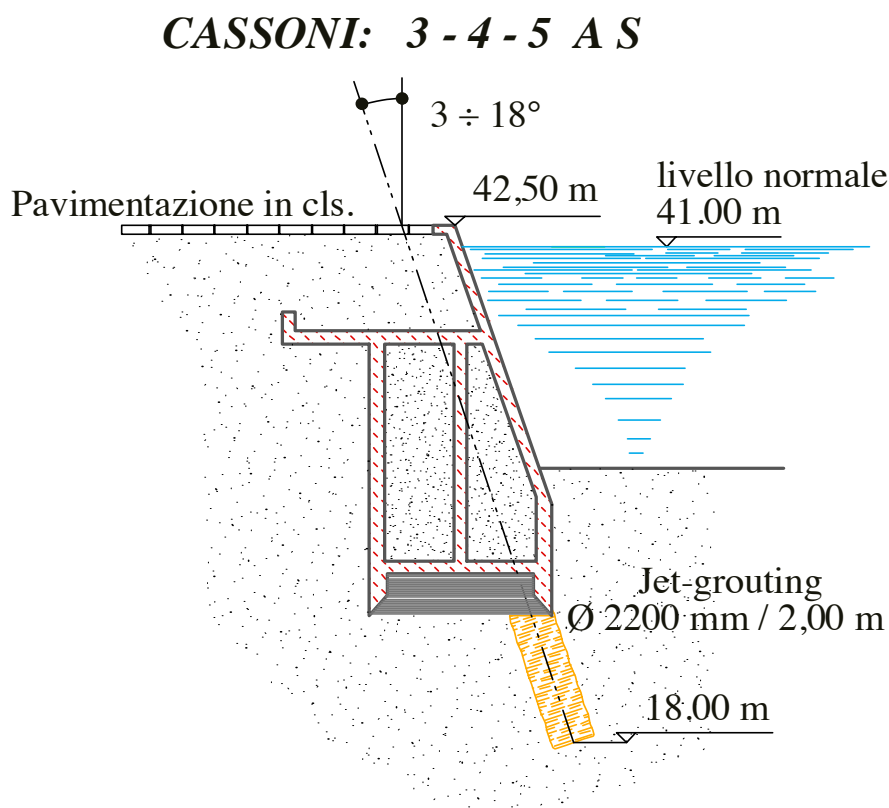
Early signs of erosion were also involving the foundation soil of caissons 3AS, 4AS and 5AS, also on the river bank to the right of the inlet. ENEL, therefore decided to extend the works to these structures. Works on both areas were performed using different methods and are therefore described separately.

Fig. 6. Sketch of intervention.

The works of consolidation of the foundation soil under the caissons were carried out with the same Jet Grouting technology (PS3) used for the previous works. The treatment was done at a distance of about 2 m from the outer edge of the caissons with two rows of quincunx columns 0.9 m apart, having the following characteristics:

- a Spacing: 2 m;
- a Diameter: 2,20 m;
- a Length: 3-6 m;
- a Angle: variable between 3° and 18°.

The construction of every column was preceded by core sampling of the caisson structure in reinforced concrete. The control holes were made with continuous core sampling. The consolidated soil samples gave values of resistance to compression between 12 and 25 Mpa, higher than the minimum established by the project specifications.
