## MEYSSIEZ (FRANCE)

Consolidation for protection of the excavation of a section of the Meyssiez tunnel built to extend the TGV Paris-Valence railroad line.

1992-1993

S.N.C.F. TGV RHONE-ALPES

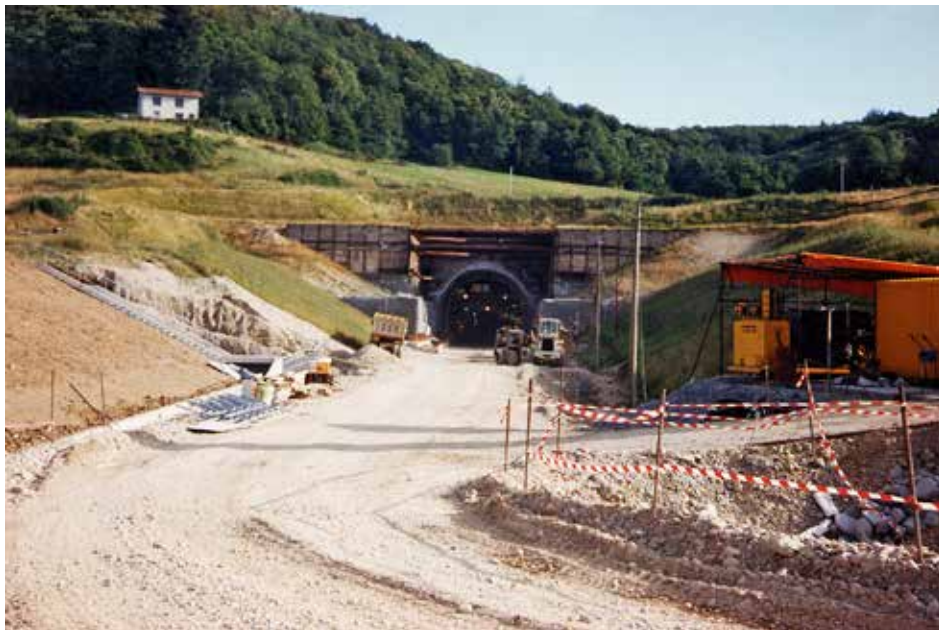
Fig. 1. View of tunnel entrance.

The excavation of the Meyssiez tunnel (Fig. 1), already completed in half section along its full length (1787 meter), had been interrupted in November 1991 due to signs of weakness shown in the dome between progressive points 287 and 353. Decompression of the sandy terrain, following the excavation, had caused the preliminary covering cambers (type HEB 220), which had already been installed, as well as a general lowering of the cap. The geotechnical features of the overhanging rock mass had been made precarious by the presence of sand lacking cohesion and affected by an abundant circulation of water, which could be seen from the many infiltrations throughout the length of the tunnel. The resistance of the rock that, during

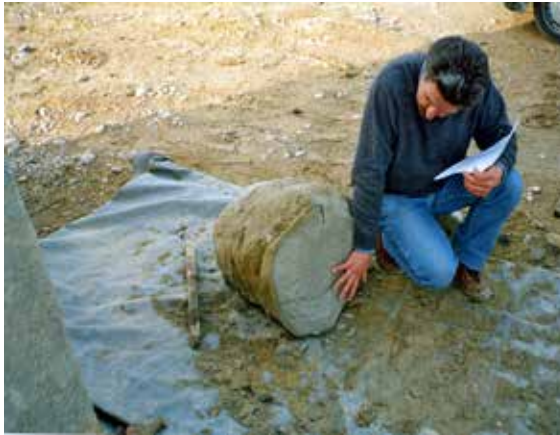
Fig. 3. View of Jet Grouting column from test field.

The method applied to perform the works was the **Pacchiosi Jet Grouting System 1 (PS1)**. The system was tested with a field trial inside the tunnel, to optimize the injection parameters in relation to the characteristics of the soil to be treated. Six vertical columns 5 meters long will be built, with different injection timing, pressure, capacity, etc. Excavation of the columns served to measure the diameter and quality (Fig. 3). The

samples drawn and sent to the laboratory have average values of resistance to compression around 11.77 Mpa.

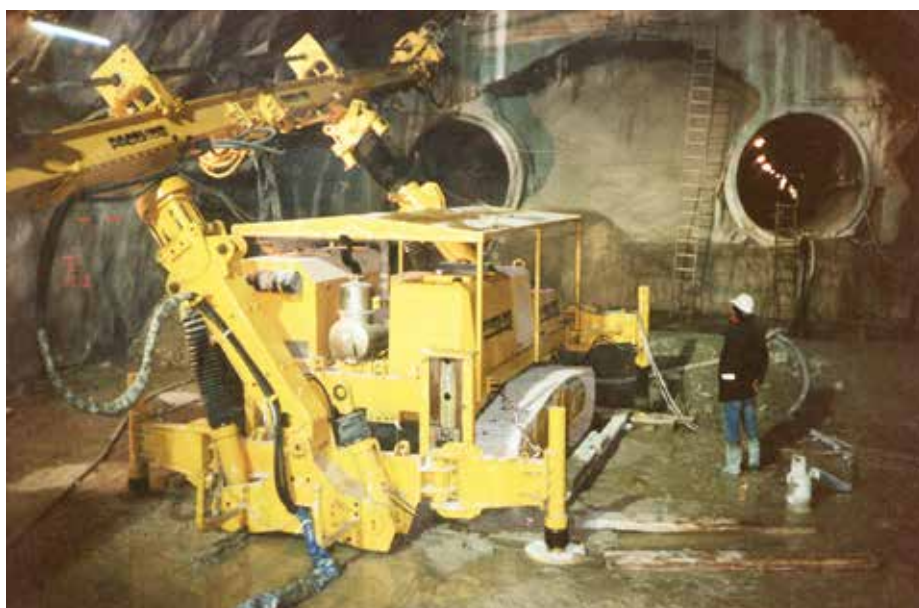
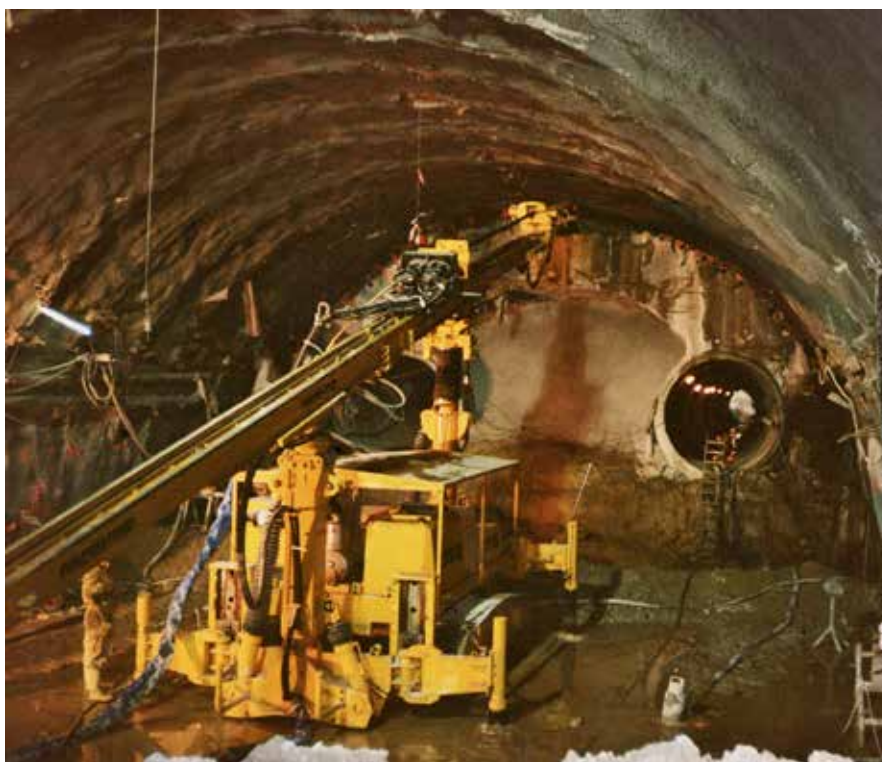
Fig. 6 - 7. View of the P 1500 TAF drill rig used for consolidation of the vault.

- Consolidation of the cap. The works were carried out using sub-horizontal columns with a spacing of 50 cm, reinforced with steel piping, 15 m long, with a diameter of 60 cm; the excavation was guaranteed by the overlapping of the reinforced columns (minimum 7 m) (Fig. 5 -7);
- Consolidation of the piers. The works consisted of two sets of columns with variable inclination, not reinforced, 7 m long with a diameter of 60 cm (Fig. 8-9);
- Installation of reinforcing micropiles at the foot of the cambers. The works consisted of construction of a row of tilted columns at a 45° angle, with a spacing of 1.73 cm, reinforced with steel piping, 9 m long with a diameter of 60 cm (Fig. 10-11);
- Construction of anchorages on the cambers. The works consisted of construction of a row of sub-horizontal columns reinforced with dywidag bars (26.5 mm) 6 m long, with a diameter of 40 cm (Fig. 12);

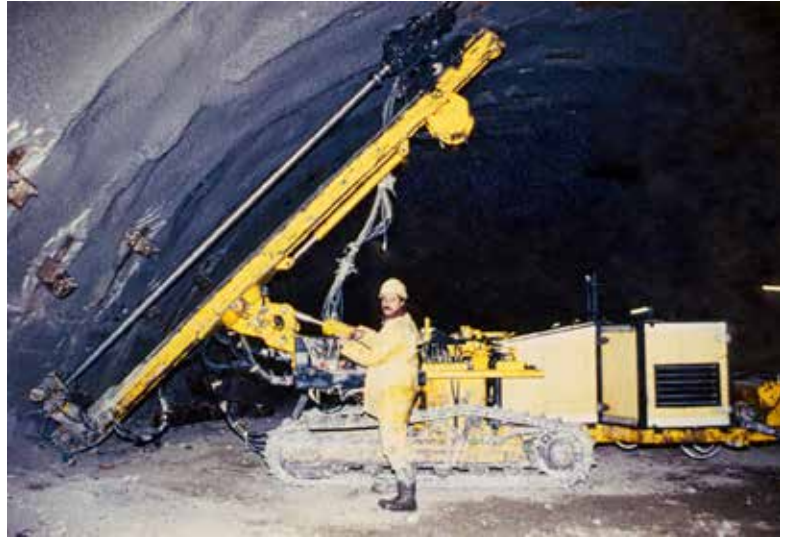
Fig. 9. PRP 105 D drill rig consolidating the piers.

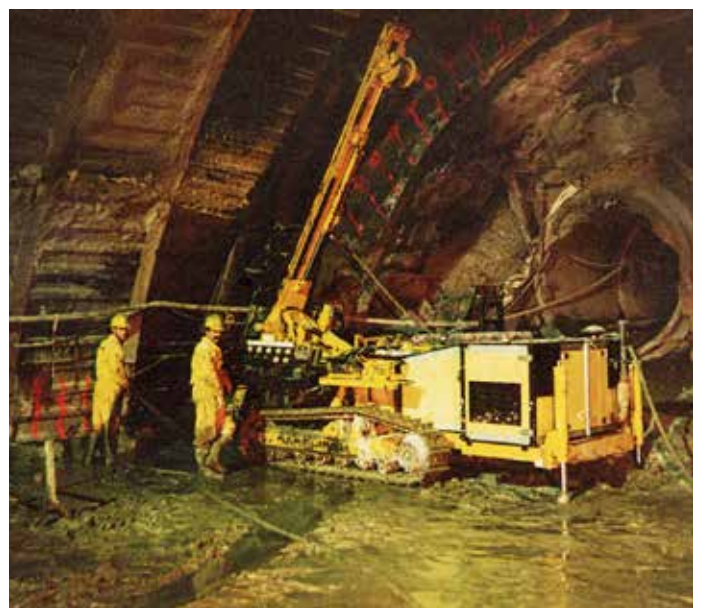
Fig. 11. PRP 105 D drill rig during construction of the reinforced columns.

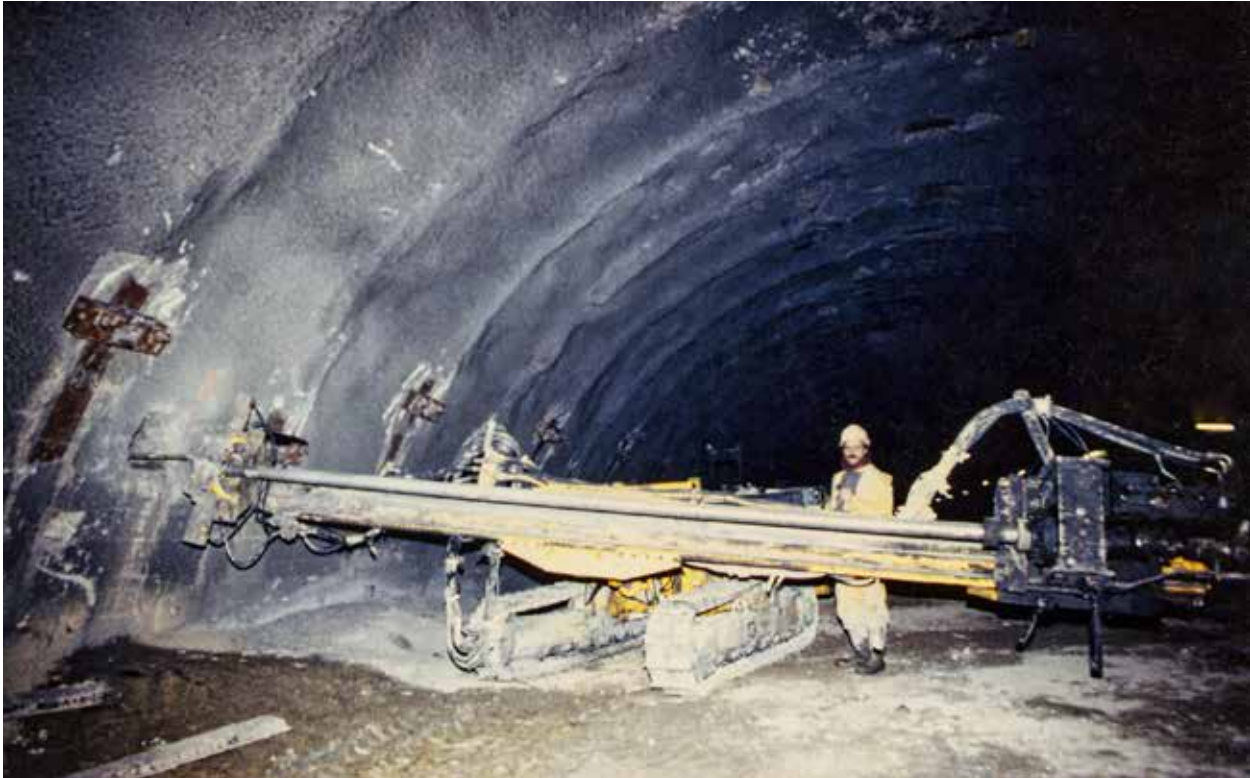
Fig. 12. PRP 105 D drill rig during anchorage of the cambers.
